# Bourdilion Field

Goring-on-Thames Parish Council

19 July 2018

# Safety Inspection Report

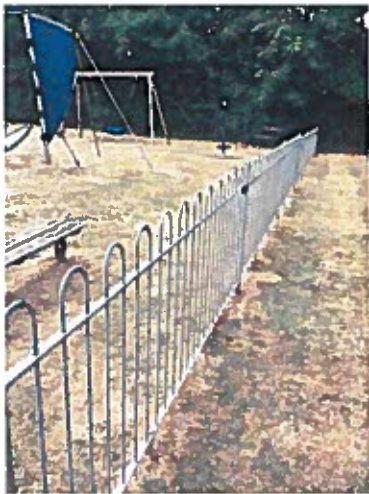
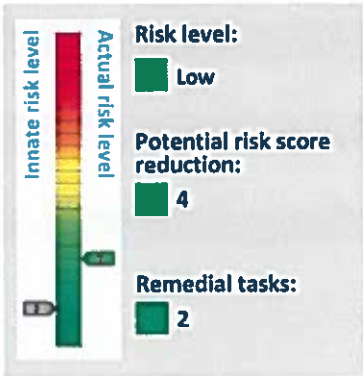
<b>Description</b>
Item is damaged.
<b>Tasks</b>
Repair.
<b>Note</b>
Fence is bent in various places

Fence is bent by wooden bench

Very low

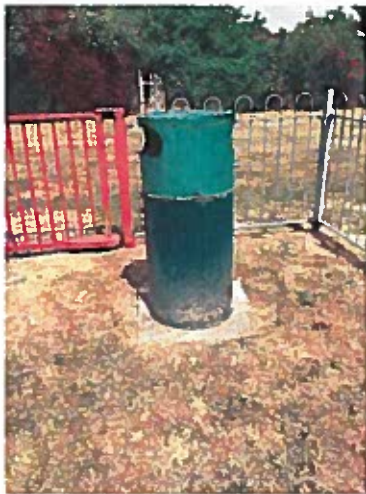
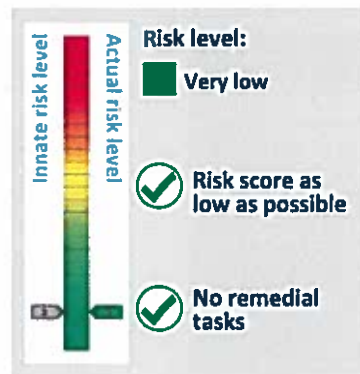
Loose in ground.

Bin is free standing.

Very low

No Tasks for this Finding

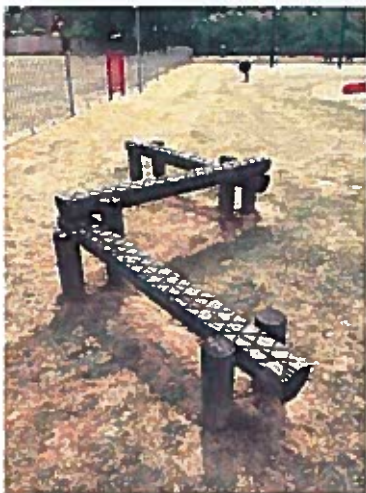
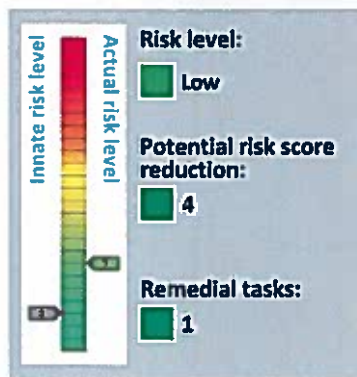
Strimmer damage to supports is likely to accelerate timber rot.

Low

Prevent further damage.

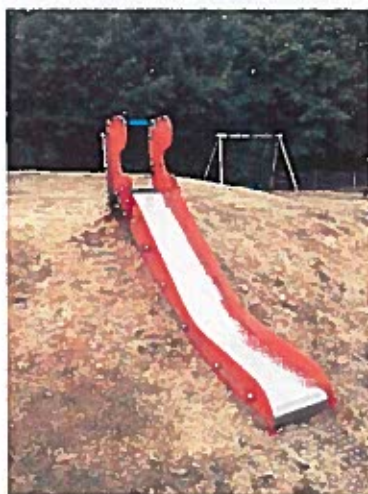
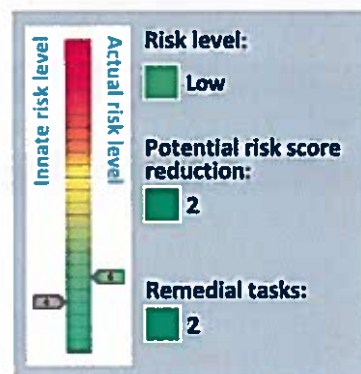
Bolt(s) missing.

Start section step is missing bolts.

Hard or sharp projections.

Screw protruding at start section of slide.

Replace missing bolt(s).

Remove hard, pointed and sharp projections.

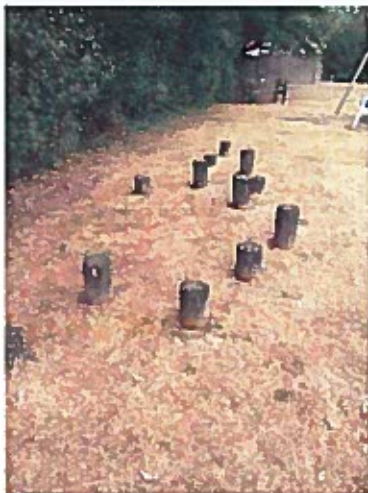
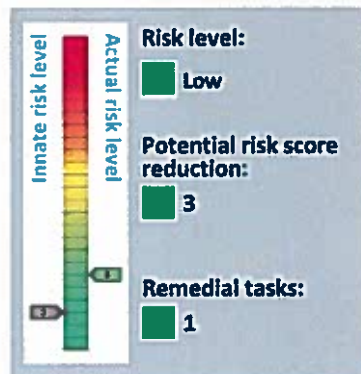
Strimmer damage to supports is likely to accelerate timber rot.

Low

Prevent further damage.

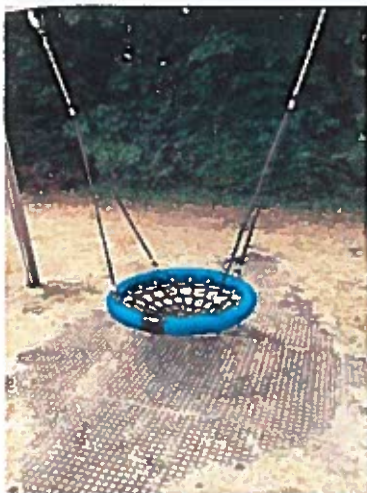
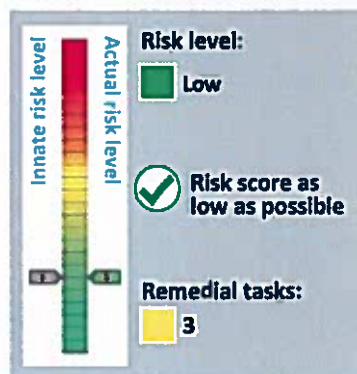
The item is not compliant with the requirements of the relevant standards.

Vandalised (arson).

Fire damage to basket, wire exposed.

The surface is damaged.

Surface damaged under basket.

Seat(s) set at incorrect height.

Repair.

Adjust to minimum of 400 mm.

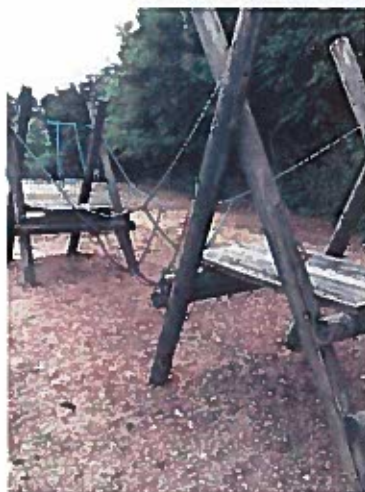
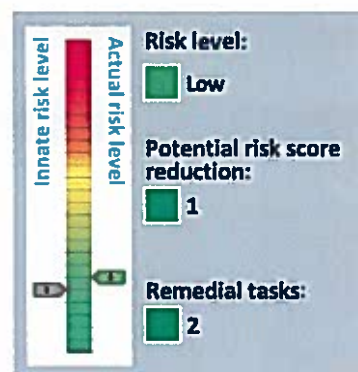
Some chain wear.

Surface is compacted or displaced.

Monitor for further deterioration and replace before 40% wear.

Rake and fork over and top up as required to maintain minimum depth (usually 300 mm).

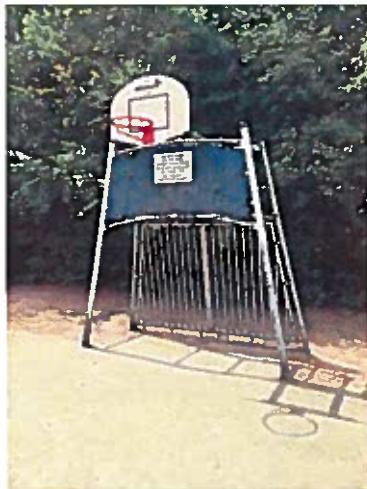
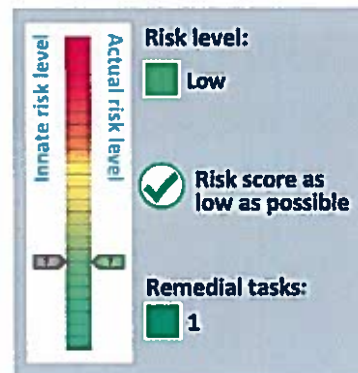
Surface needs repair.

Edge of carpet worn and needs repair.

Repair.
