**CONDITION SURVEY
REPORT**

**THE OLD JUBILEE FIRE
STATION, GORING ON
THAMES**

**GORING PARISH
COUNCIL**

JUNE 2021

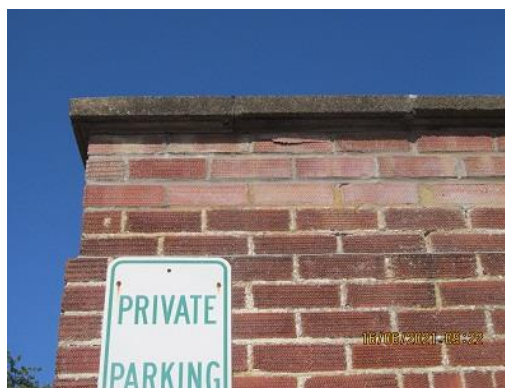
Photo 3 – Staining below front parapet; laminating bricks

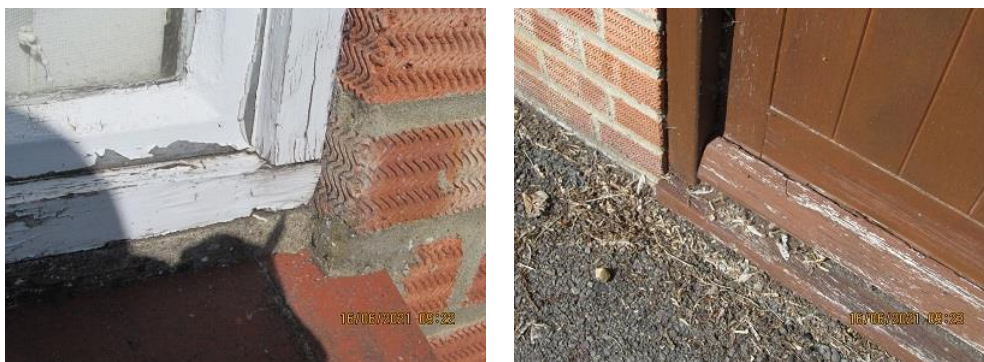
7.7	External stairs	n/a	n/a	n/a	0.00	-
7.8	Windows	<p>Crittall single glazed steel frames in painted timber sub frames.</p> <p>Traditional painted timber casement windows, with glazing bars.</p>	<p>Worn condition. (see decorations later). Cracked putty, Rot to sub frame Meeting Room window. Rot to sub frame left elevation office window.</p> <p>Gaps between frames and surrounds will allow water penetration by capillary action.</p>	<p>Overhaul windows; cut out areas of soft and rotten timber and splice in new VAC VAC treated sections.</p> <p>Rake out open joints around frames and mastic seal (foam or</p>	<p>450.00</p> <p>incl</p>	1,2,4,9,12

Photo 4/4A – Rot window sub frames; loose weatherboard

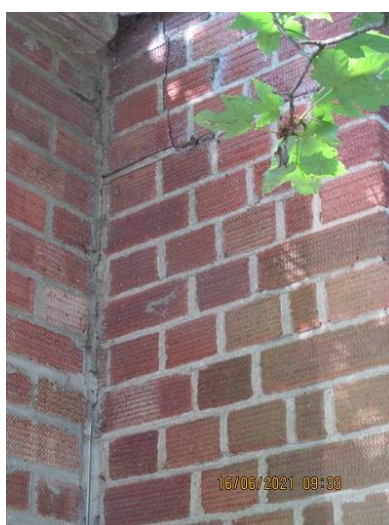
A significant 16m approx. height Field Maple or similar tree is at just 2.5m from the front corner of the property, with evidence of slight differential movement to the front infill extension which may be exaggerated by tree root action on the sub strata and/or foundations.

Photo 6 – Cracking between front infill extension and original

A Specialist Arboriculturalist should be engaged to report upon the condition of the tree and the potential for future damage to the building structure or persons (NB; the tree itself is on the boundary line and liability may therefore be jointly with the adjacent Doctor's surgery).

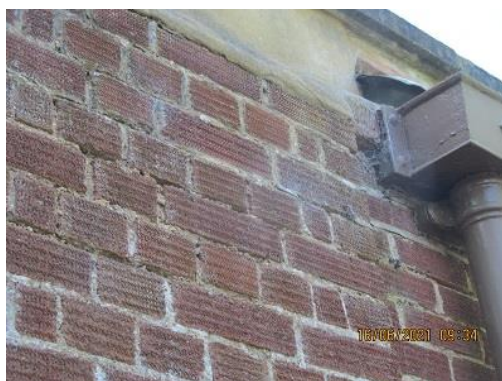
Photo 7 – Open jointed brickwork

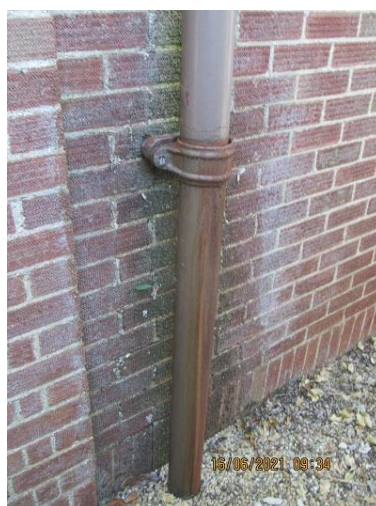
Photo 8 – Water damage to right elevation

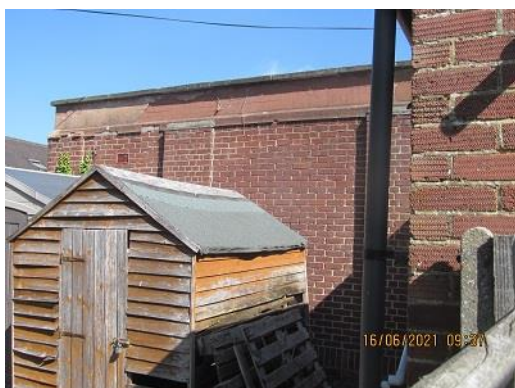
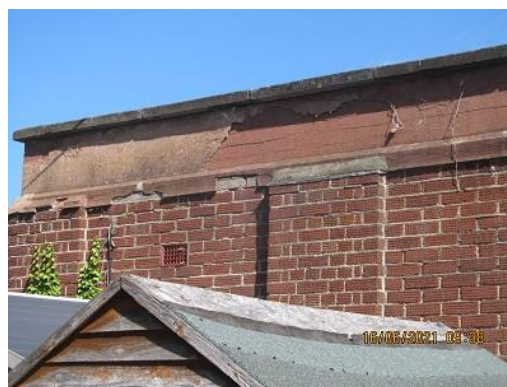
Photo 10/10A – Rear left elevation/addled and cracked rendering

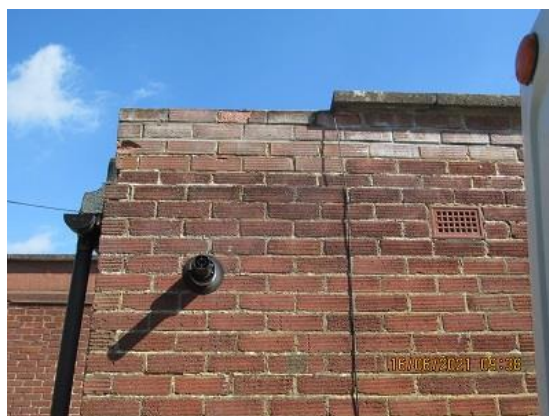
Photo 11 – Missing parapet copings

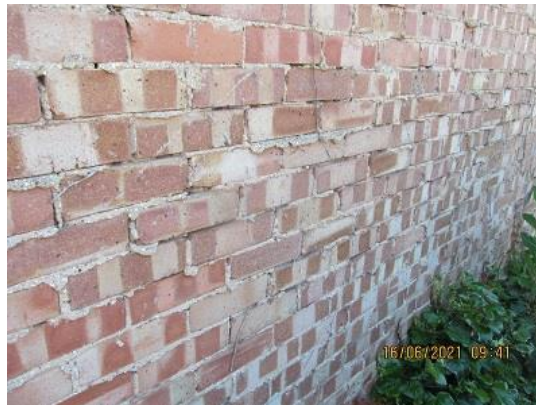
Photo 14 – Open jointed rear clay common brickwork

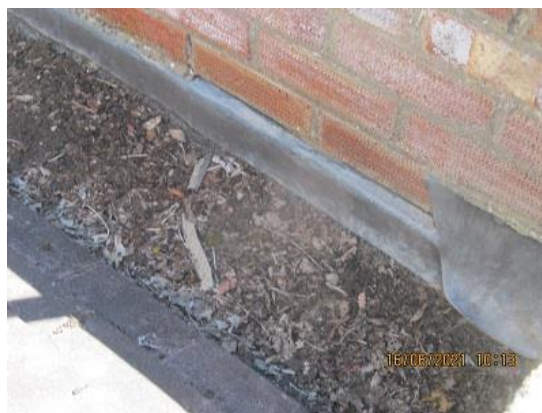
Photo 16 – Blocked parapet gutter/flashing pulling from masonry

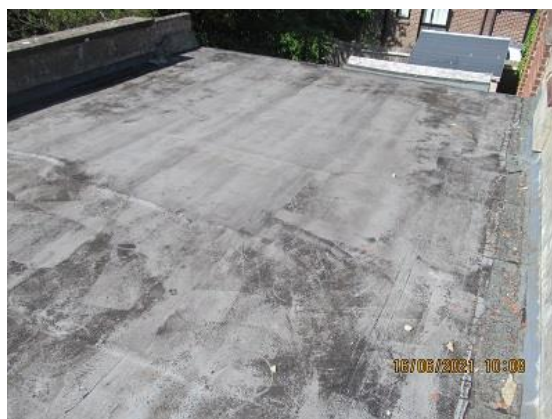
Lower flat roof	Traditional BS747 type felt roof with solar reflectant coating centrally and mineral felt perimeter upstands.	Life expired. Surface rippled. Solar coating worn and cracked. Worn and cracked perimeter mineral felt upstands.	Strip and recover roof in High Performance felt or similar (Bauder or similar); upgrade	9,000.00

Photo 17 – Lower flat roof

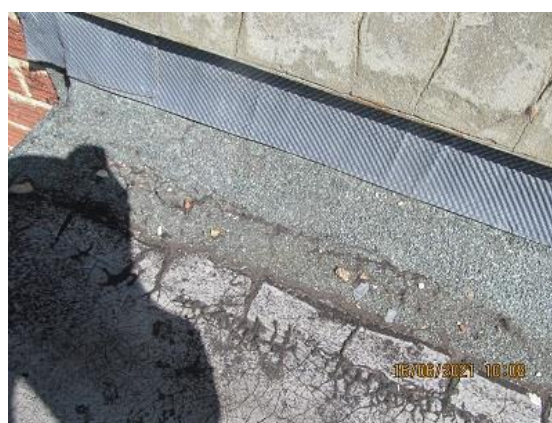
Photo 18 – Cracks to felt verge

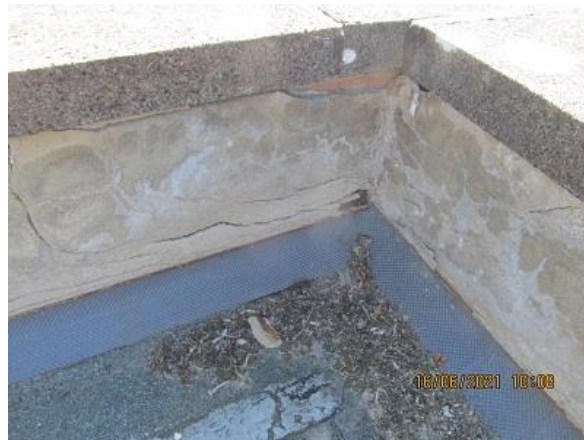
Photo 19 – Cracked and addled rendering inner face parapet

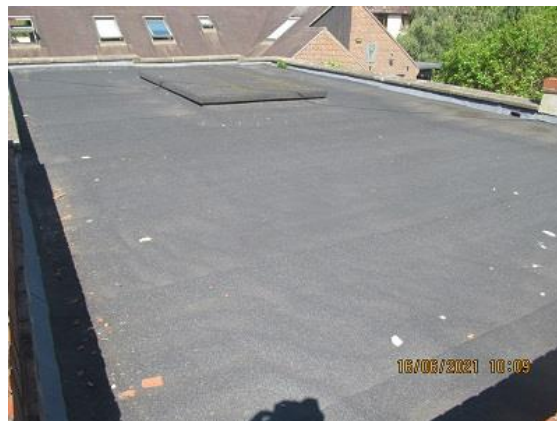
Item	Location	Description	Condition	Repair	Budget Cost (£)	Photo Reference
7.0	EXTERNAL					
7.1	Roof Upper flat roof	Flat roof with High Performance mineral felt overlay. Centre raised former rooflight areas. Felt perimeter upstands to parapet copings or rendered parapets.	Fair condition. Slight undulation to surface, with evidence of standing water. Worn areas of mineral finish.			16,17,18,19 20,21,21A
	Flashings	Replacement lead substitute proprietary cover flashings.	Fair condition. Areas not fully bonded. Assumed lead substitute flashings have been fitted due to vandalism or attempted theft of leadwork.			
	Parapets	Concrete copings/brick on edge to masonry parapets, rendered internal face to front of roof area.	Worn condition, with life expired elements . Cracked rear coping. Open joints to copings. Rendering extensively cracked and addled. Render bead corroded and loose. Resulting water ingress to interior. Ivy growth blocking rainwater outlet.	Take off copings and remove cover flashings; hack off and replace all inner parapet face rendering; replace correctly detailed and bonded lead substitute cover flashings (Ubiflex or similar); reinstate copings; repoint copings and replace cracked coping stone. clear ivy.	3,500.00

Photo 20 – Upper flat roof

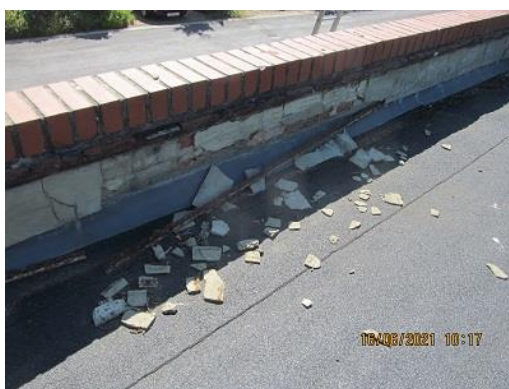
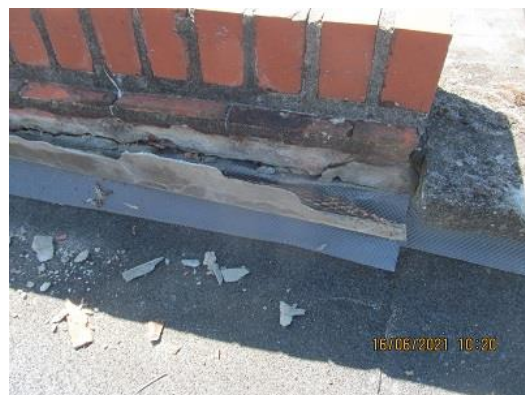
Photo 21/21A – Cracked, addled parapet rendering and corroded angle bead

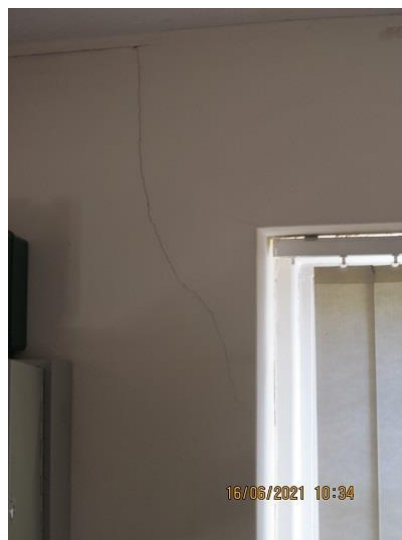
Photo 22A – Cracking above window openings

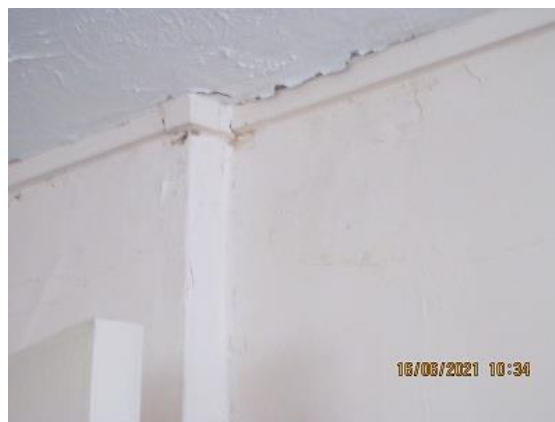
Photo 23 – Damp staining and water damage office ceiling

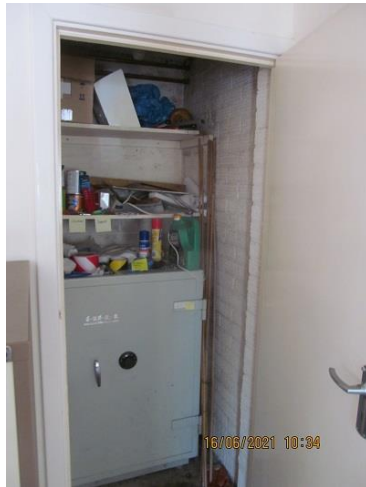
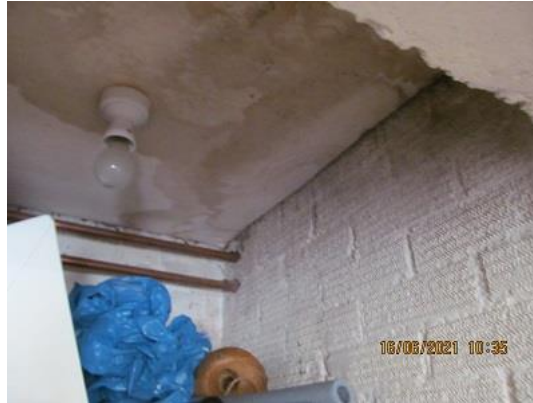
Photo 24/24A – Cupboard/damp and black spot mould ceiling

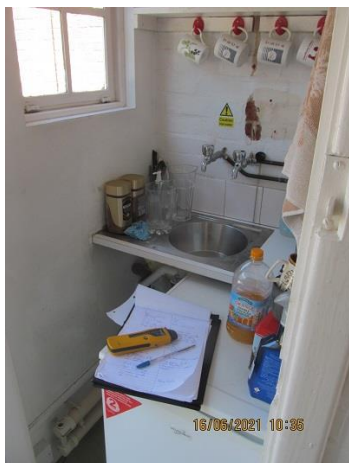
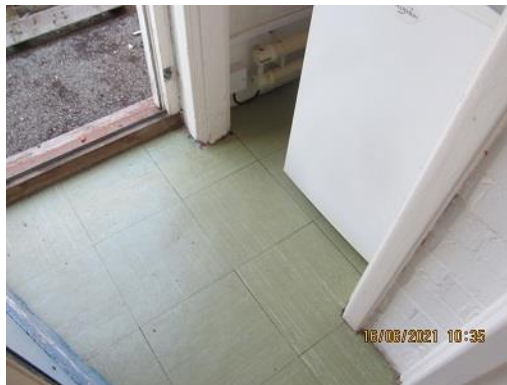
9.3	Floors	Thermoplastic tile, floor paint and carpet (with some exposed concrete slab).	Worn condition. Carpets worn and aged. Thermoplastic tiles may contain Chrysotile (see previous comment on Deleterious Materials) but are non hazardous whilst intact. Floor paint to rear Store Room life expired .	Replace carpeting to main office and Meeting Room. Prepare store room floor and apply proprietary floor paint.	5,500.00	22,25A,29

Photo 25/25A – Teapoint/thermoplastic tiles

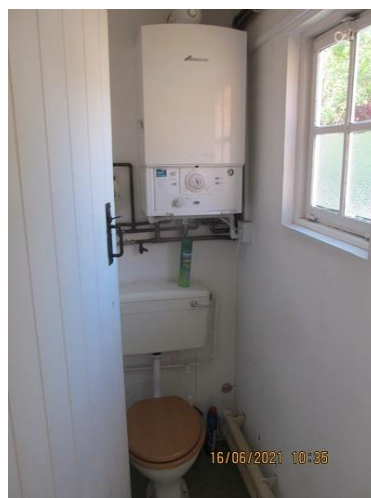
9.8	Bathroom/Toilet Facilities	Small toilet cubicle off rear vestibule. Low level wc suite (non matching pine seat).	Fittings functional and in fair condition. Cantilevered wc pan generally preferred due to ease of washing under. No mechanical extraction. Toilet is not DDA compliant for either wheelchair users or the ambulant disabled.	Install mechanical extract fan.	300.00	26

Photo 26 – Toilet

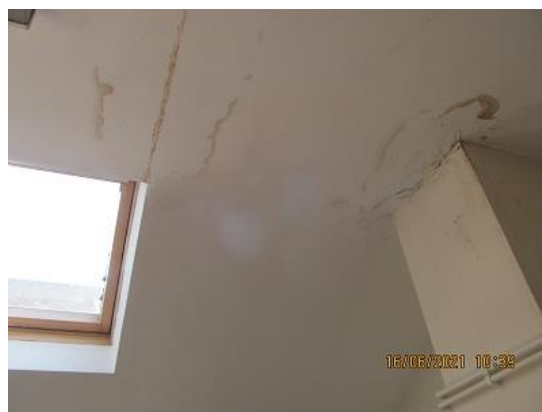
Photo 28 – Damp staining Meeting Room ceiling

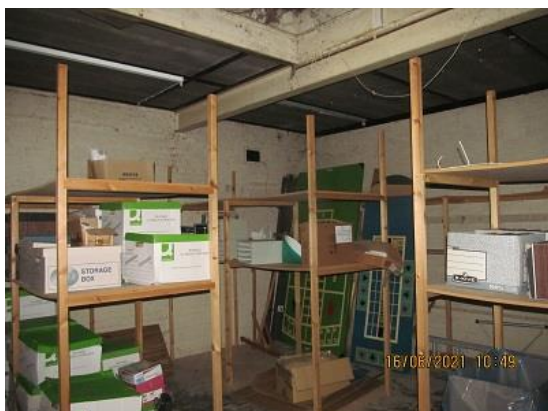
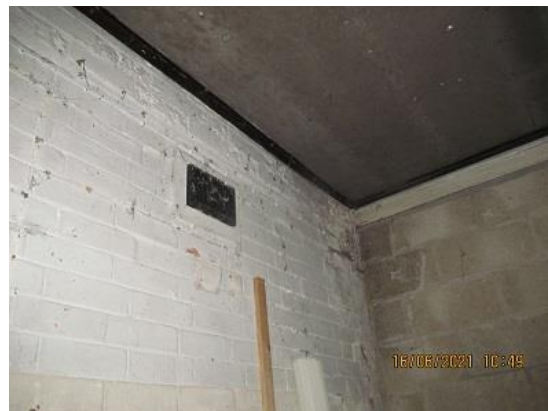
Photo 30/30A – Rear Store Room/fibre cement ceiling & water ingress high level

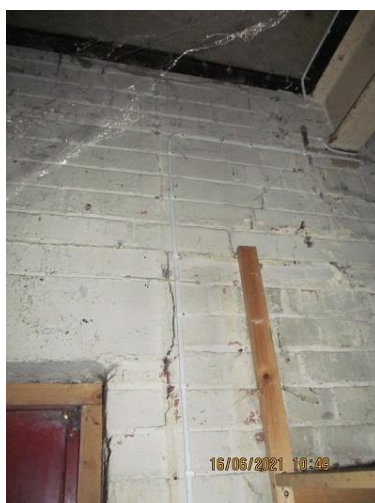
Photo 31 – Cracking above rear door head

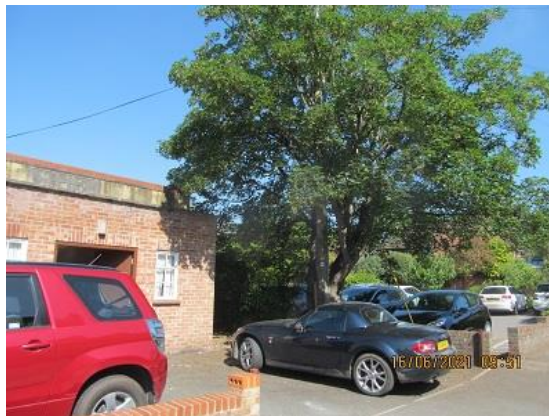
Photo 37 – Proximity of tree to property

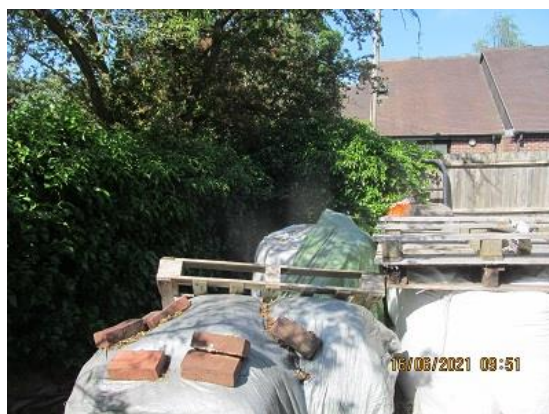
Photo 39 – Overgrown boundary fencing

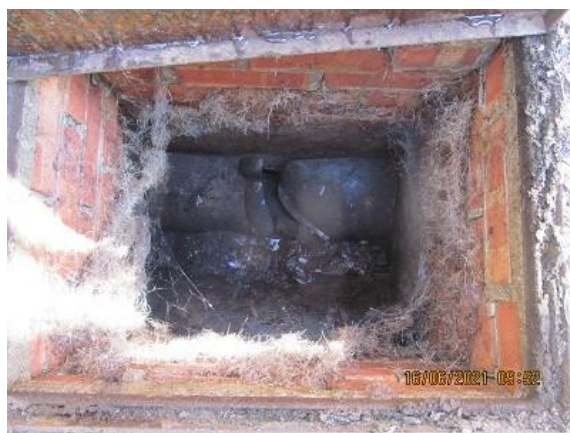
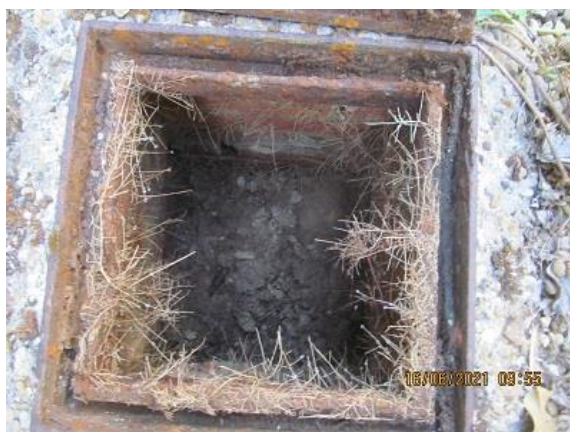
Given that the drains are fully blocked with root growth and stranded solids to the rear, a Specialist CCTV inspection should be carried out, with a written and visual report issued, including recommendations for any remedial work over and above jet washing and rodding the drains, which will be required to enable the CCTV testing.

10.10	Drainage below ground	<p>Access to drainage via 1No chambers;</p> <p>Drainage inspection chamber 1 (to left elevation) Medium duty cover and frame to brick chamber approx. 800mm deep. Base half round pipe running rear to front, with direct branch from property toilet area.</p> <p>Small heavy duty access cover to soakaway in right gravel path.</p>	<p>1No heavy duty chamber cover to front hardstanding– unable to inspect</p> <p>Root growth on brick shaft walls. Base half round pipe fully blocked standing solids.</p> <p>Root growth in chamber; inlet likely to be blocked and therefore contributing to back up and water staining on side elevation where downspout joint open. Soakaway too close to property (minimum 5m from property required under Building Regulations).</p>	<p>Evidence of defects within drainage below ground, with extensive fine root growth to access chamber and drain within chamber completely blocked. The drains will need to be rodded through and jet washed to clear and enable a Specialist CCTV inspection, to include the inlet to the soakaway. Soakaway may need to be reformed or surface water to right redirected to mains.</p> <p>Costs for further investigation and testing only included.</p>	500.00	42,43,44

Photo 42 – Drainage inspection chamber

Photo 43 – Soakaway
