Central Goring Survey of Pavements and Dropped Kerbs (DK) June-August 2022

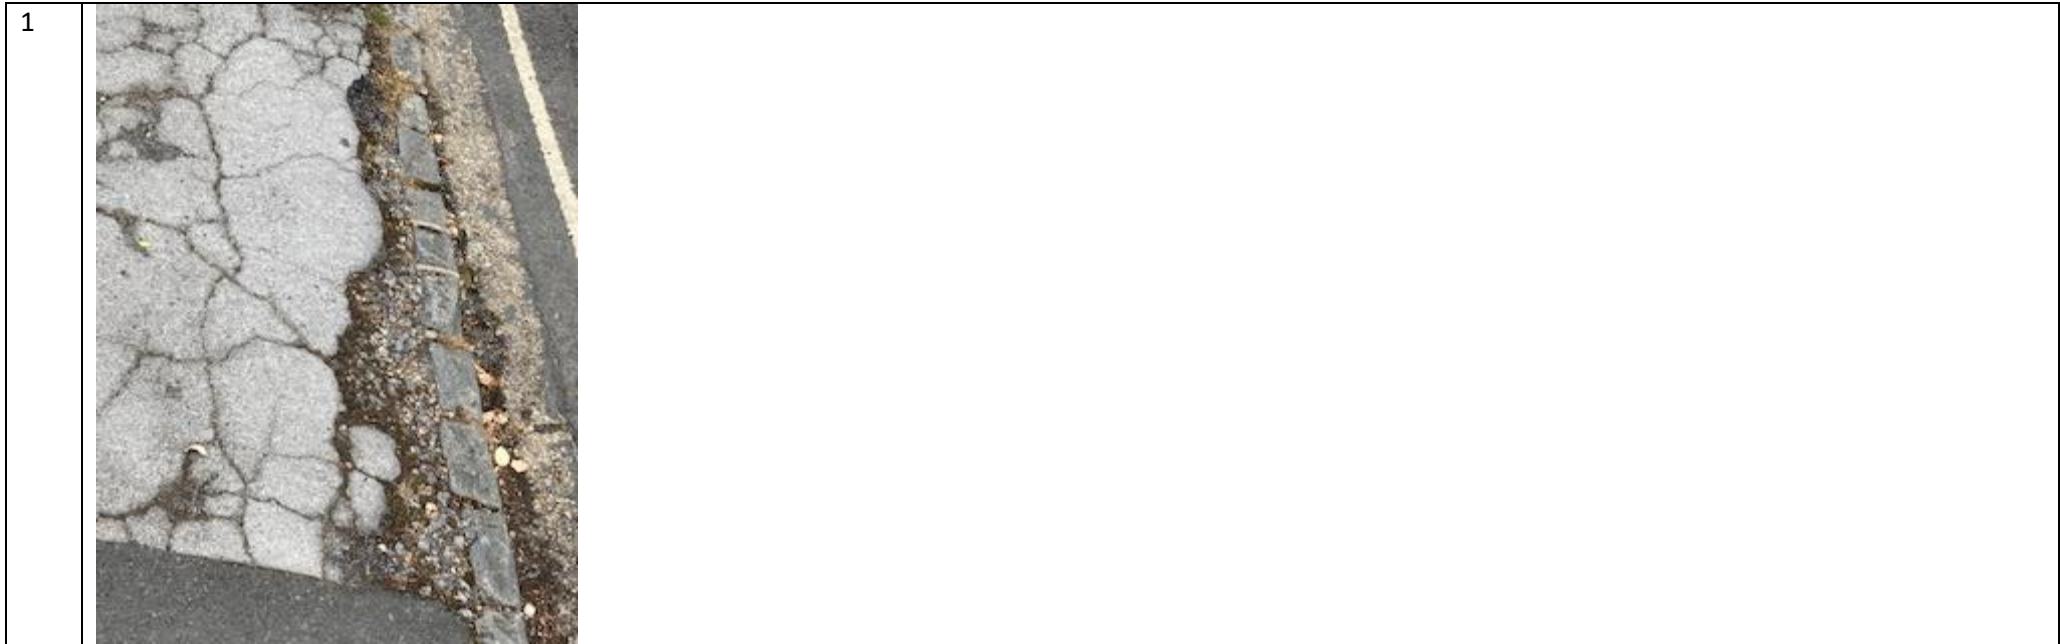
Road Rd	Map ref.	Location	Problem	Solution
Holmlea Rd.	1	Junction of railway path and HR	The temporary tarmac slope is disintegrating. Steep camber on both sides of HR.	Resurfacing and reduction of camber and DK construction
Croft Rd Station Rd junction	2 No photo	Junction of Croft R and Station Rd	The pavement on the east (station) side of Croft Rd. fizzles out on this hazardous junction with poor visibility in 3 directions and an uneven surface.	Dropped kerb has been recommended on the station side of Croft Rd. and was agreed in principle in the May survey by Cllrs SL and DB.
Red Cross Rd and Station Rd junction.	4	Opposite Hardware shop	The only pavement is on the shop side. This junction has limited visibility and takes 4-way traffic. An additional hazard for pedestrians is the large number of heavy vehicles and delivery vans manoeuvring at this tight junction.	A DK would give access to the pavement on the shop side from the railway side of the road.

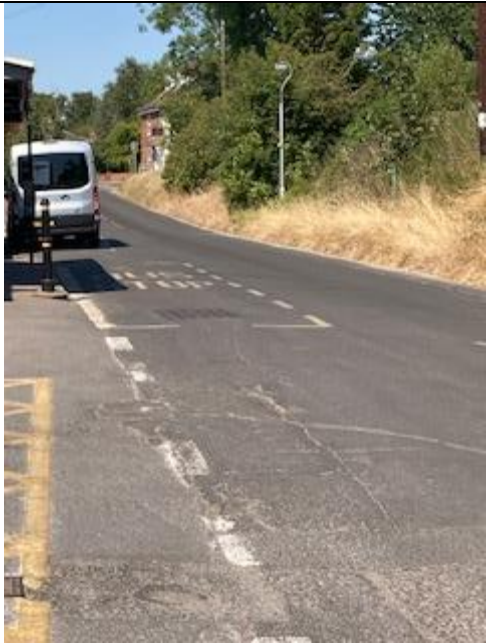
Tescos	12 -13	TESCO -Station	High volume of vehicles including buses, school coaches, taxis, pedestrians on sloping pavement. Multi-directional checking required.	Speed restriction to reduce temptation to speed, DK exists here. Very limited pavement on Tesco side. DK needed here on both sides.
