# Bourdilion Field

Goring-on-Thames Parish Council

19 July 2018

# Safety Inspection Report

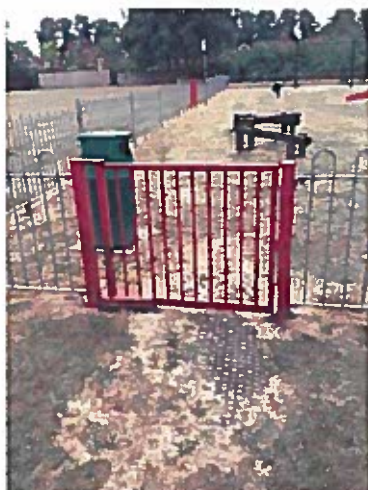
## Gates x 2

Loose in ground.

Strimmer damage to supports is likely to accelerate timber rot.

Prevent further damage.

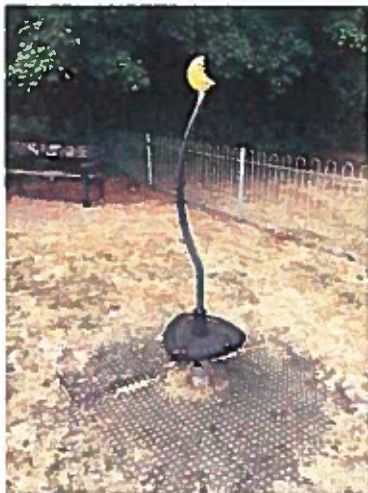
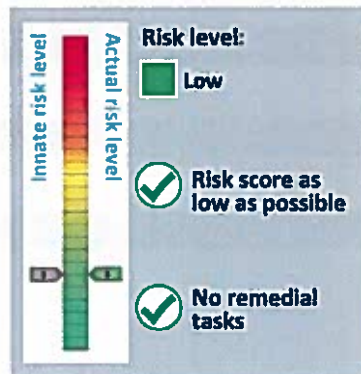
# Rotator - Spica

Bolt(s) missing.

Start section step is missing bolts.

Replace missing bolt(s).

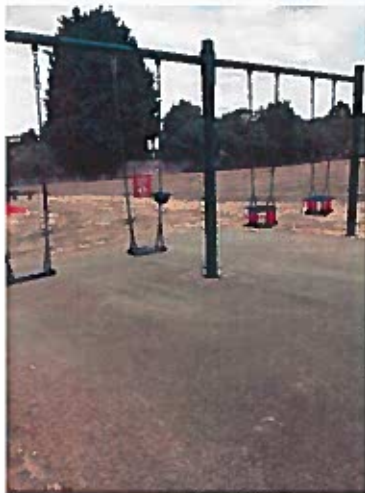
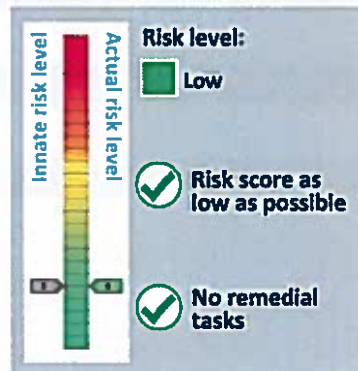
# Swing - Mixed - 2 Bay 2 Junior 2 Toddler Seat

Some chain wear.

Monitor for further deterioration and replace before 40% wear.

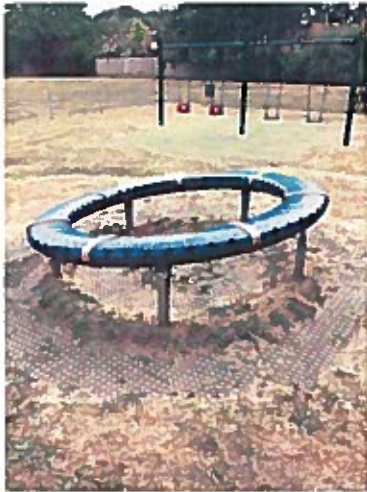
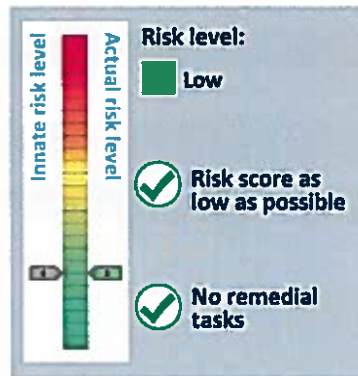
# Carousel - Supernova

Surface needs repair.

Edge of carpet worn and needs repair.

Repair.
