**CONDITION SURVEY
REPORT**

**THE OLD JUBILEE FIRE
STATION, GORING ON
THAMES**

**GORING PARISH
COUNCIL**

JUNE 2021

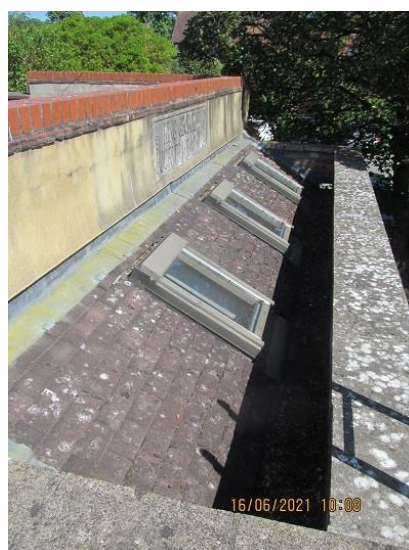
Photo 15 – Infill extension pitched roof

Front pitched roof	Monopitched roof with covering of plain concrete tiles.	Fair condition.			
	Flashings/parapet gutter	Lead upper and flank flashings. Felted parapet gutter with lead cover flashings to parapet.	Worn condition with life expired elements . Worn felt gutter lining. Lead cover flashings pulling away from parapet; open joint with resulting	Srip back tiling and remove felt gutter lining; reline gutter in	1,000.00

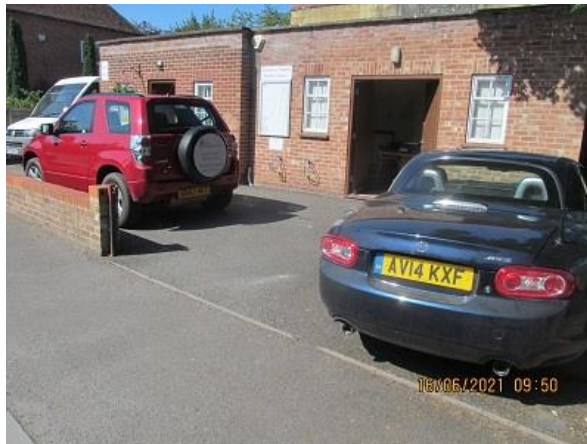
Photo 36 – Front site

A significant 16m approx. height Field Maple or similar tree is at just 2.5m from the front corner of the property, with evidence of slight differential movement to the front infill extension which may be exaggerated by tree root action on the sub strata and/or foundations.

A Specialist Arboriculturalist should be engaged to report upon the condition of the tree and the potential for future damage to the building structure or persons (NB; the tree itself is on the boundary line and liability may therefore be jointly with the adjacent Doctor's surgery).
